TS-PIC-9703332S
December 1996

AERIAL PHOTOGRAPHIC ANALYSIS 68TH STREET DUMP Baltimore, Maryland

AERIAL PHOTOGRAPHIC ANALYSIS
68TH STREET DUMP

Baltimore County, Maryland

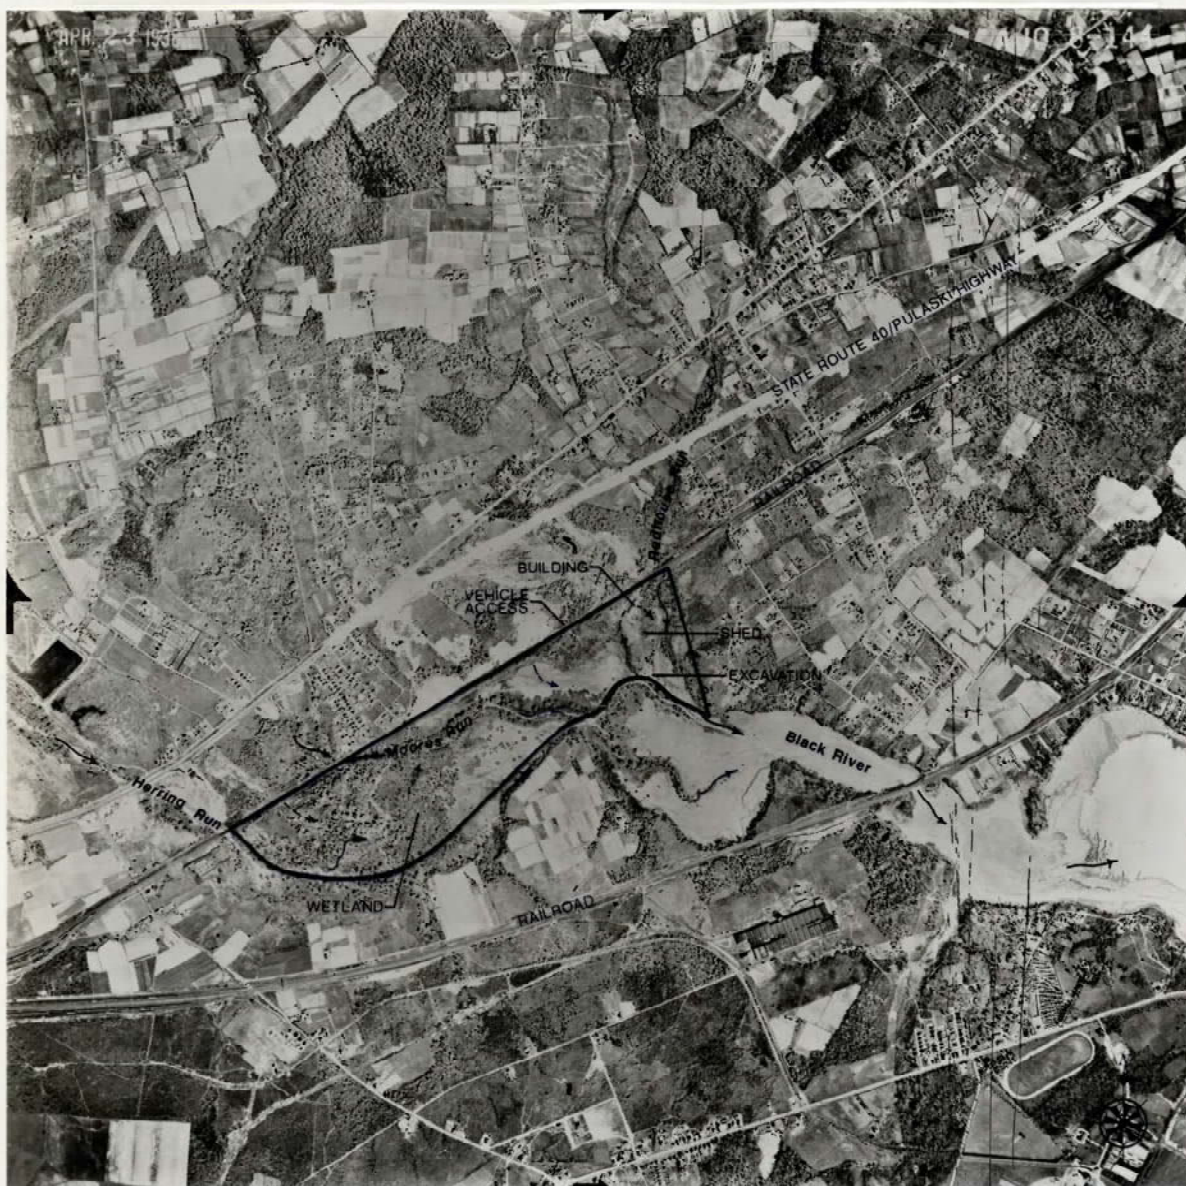
Figure 3. 68th Street Dump, April 23, 1938. Approximate scale 1:19,000.

The 68th Street Dump is not an active waste disposal landfill at this time. The site covers undeveloped, vegetated wetland along the banks of Herring Run. Natural drainage from Herring, Moores, and Redhouse Runs flow across the study area and into Black River southeast of the site. The site is approximately 1 mile in length between the railroad bridge over Herring Run to Herring Run's confluence with Redhouse Run. The railroad along the north perimeter of the site restricts vehicle access. The only vehicle access into the site is provided by one railroad crossing.

A large building and a shed are observed at the east side of the site. A large square excavation, probably for a building foundation, is south of the large building.

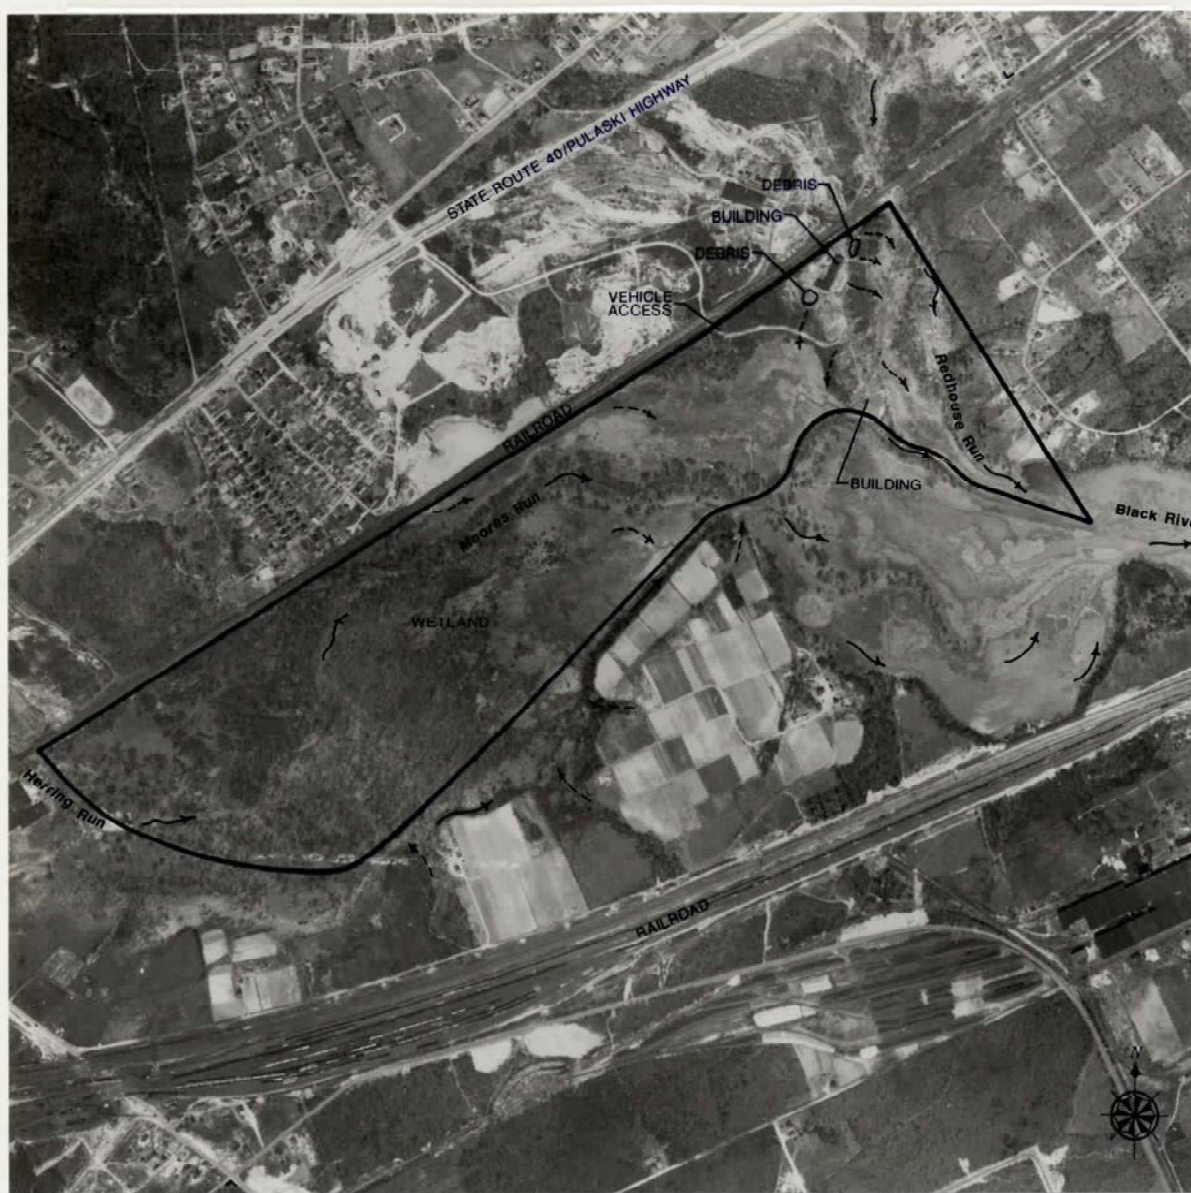
Figure 4. 68th Street Dump, April 25, 1943. Approximate scale 1:9,650.

The west and central portions of the site have remained undeveloped riparian wetland since 1938. The area next to the large building on the east side of the site has become littered with debris and open dumping, particularly along the western bank of Redhouse Run. The shed in this area has been removed. A new building has been constructed where an excavation was noted in 1938.

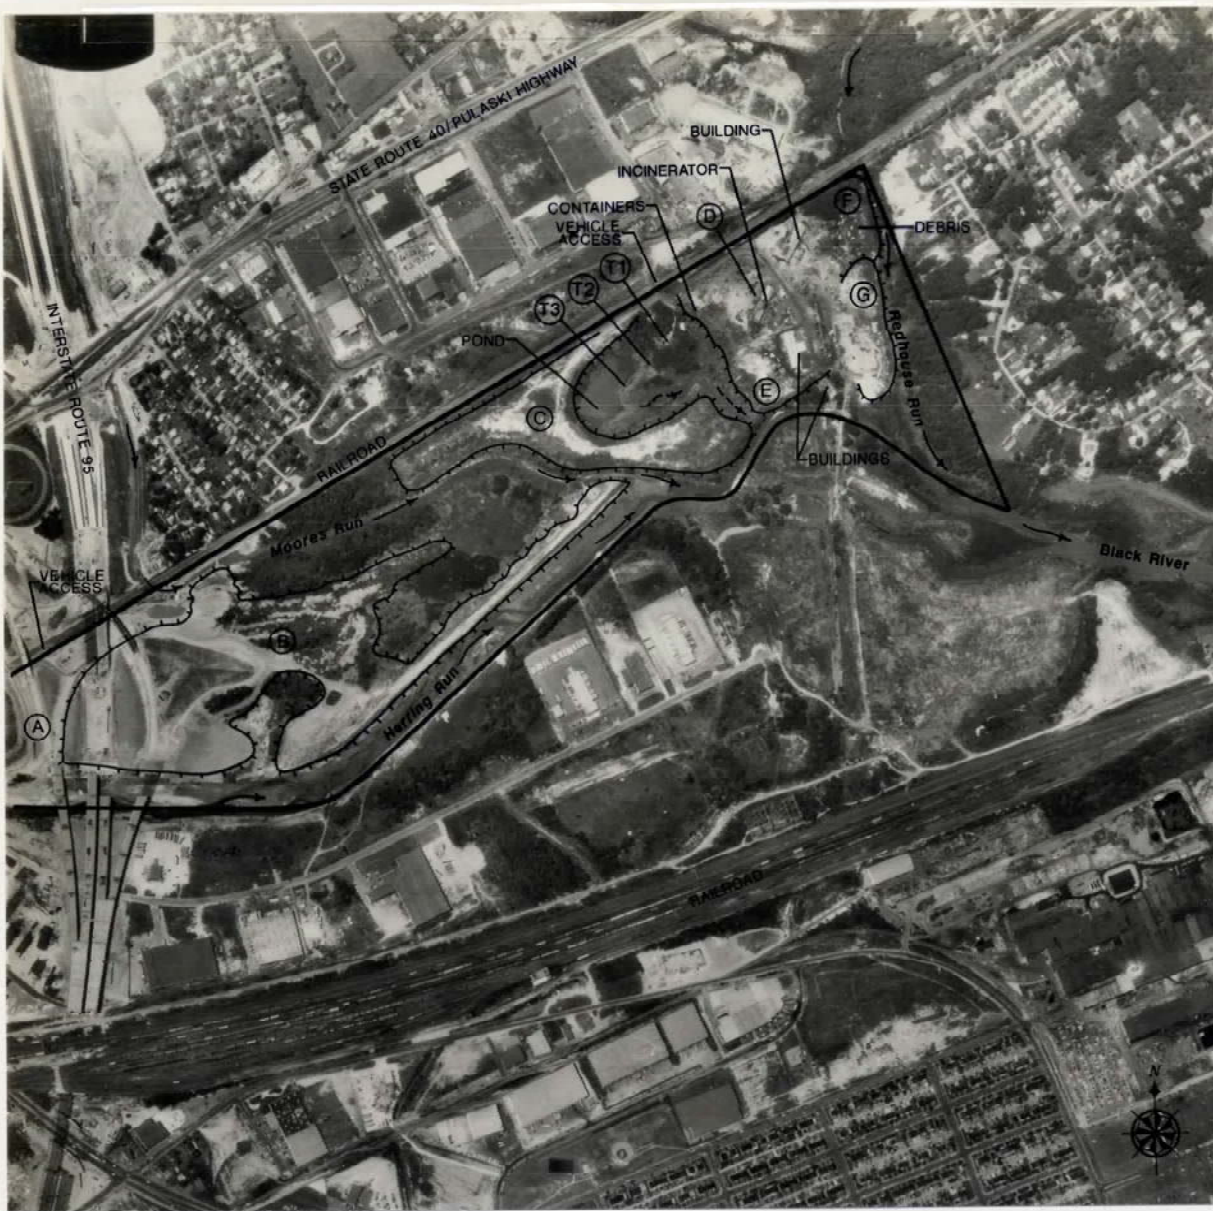
Figure 8. 68th Street Dump, June 1973. Approximate scale 1:9,000.

The site's far western edge has been transformed by construction activity into the structures of bridges, overpasses, and ramps of Interstate Route 95 (Annotation A). Additional dumping of light-toned fill has continued and now occupies the central portion of the site (Annotation B). Numerous vehicle trails into this portion of the site are visible.

Piles of light-toned material are observed on the crescent-shaped mound in the central portion and indicate continued dumping has occurred in this area (Annotation C). The radio facility adjacent to the crescent shaped mound continues to appear operational (Annotations T1, T2, T3). A pond has formed next to the radio facility.

Dumping of dark-toned material has continued on the east side of the site, west and south of the incinerator (Annotations D & E). This area, now raised above the level of Herring Run, has become an open storage yard for numerous scattered containers and accumulations of debris.

Additional fill has been hauled and dumped along the west bank of Redhouse Run at the east end of the site (Annotations F & G). These areas have also been built up and are now occupied by numerous vehicles, trailers, equipment, containers, and debris. Runoff leaving this littered portion of the site drains into Redhouse Run.

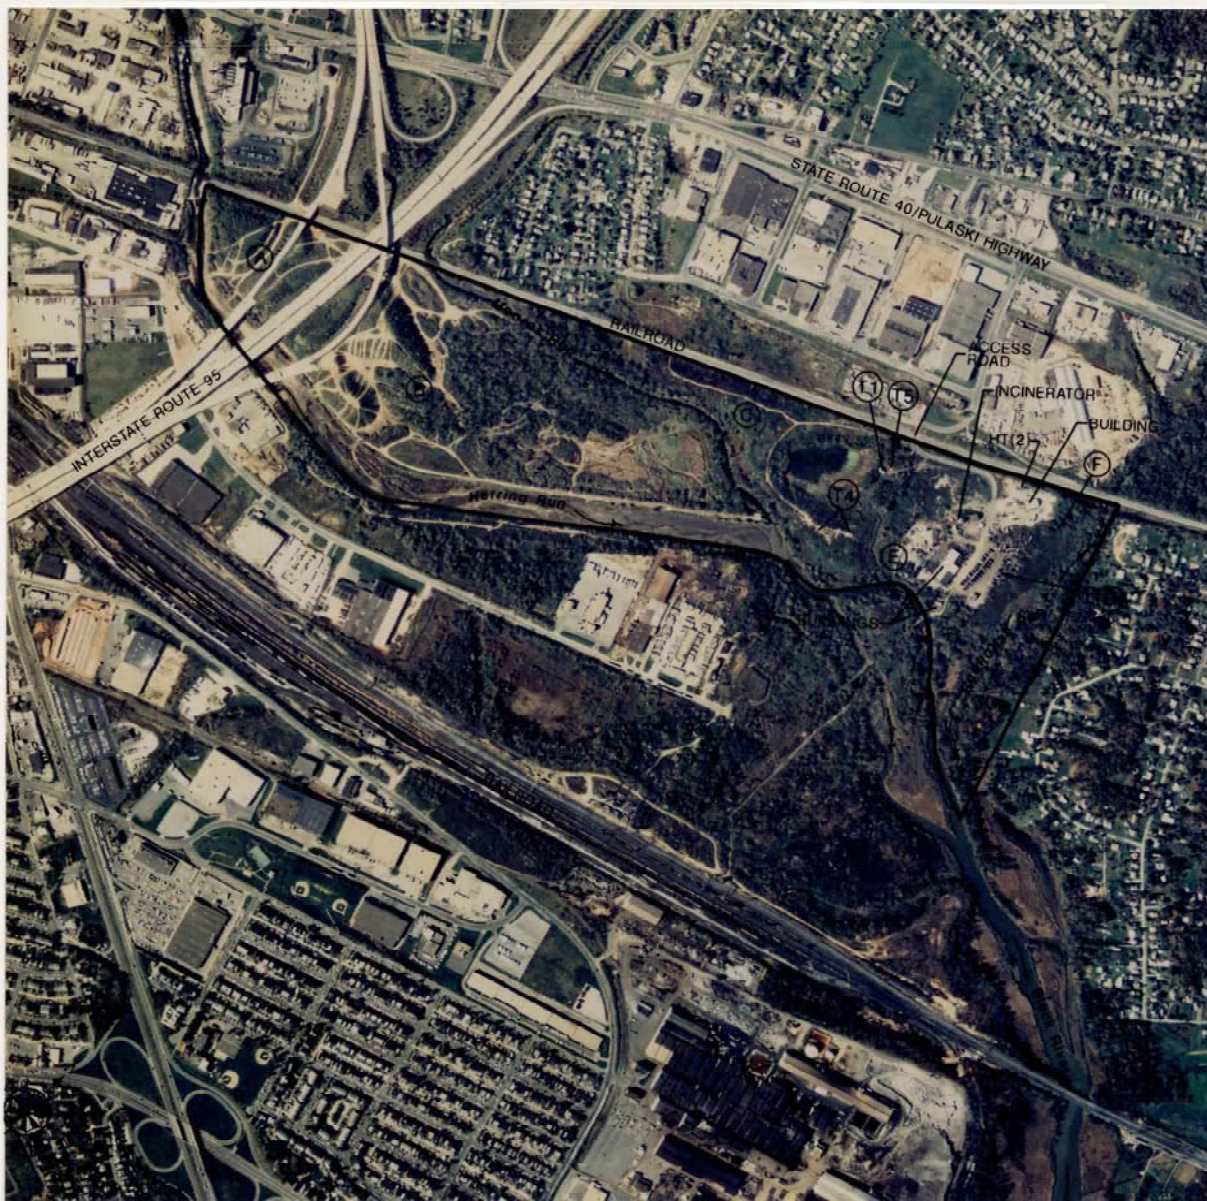
Figure 9. 68th Street Dump, November 3, 1984. Approximate scale 1:10,450.

The lack of stereo photo coverage for this year of photography precludes a complete analysis. The highway bridges and most of the ramps of Interstate Route 95 have been completed and the highway is now open (Annotation A). There are no signs of ongoing dumping and the western portion of the site has become revegetated. There are foundations for future ramps onto Interstate Route 95 that have not been put into service. Trails extend from these unopened ramps into the west end of the 68th Street Dump (Annotation B).

There is no visible sign of ongoing dumping of fill or solid waste in the east-central portion of the site (Annotation C). The antenna towers reported at the radio facility in 1973 are absent. Another set of antenna towers appear to be installed on top of the mound south of the pond (Annotation T4) and a dish antenna (Annotation T5) has been installed at the radio facility.

The incinerator is still present; however, the previously reported mounds of light and dark-toned material next to the incinerator are absent (Annotation D). Numerous crates or boxes are piled next to the incinerator.

Several vehicles are parked at the enlarged building south of the incinerator. The storage yard next to the building is filled with trailers and containers (Annotation E).

The building north of the incinerator is partially dismantled. Two horizontal storage tanks have been installed on the northwest side of this building. The eastern side of the site, overlooking Redhouse Run, has become revegetated (Annotation F). Numerous trailers and containers line the parking areas on this side of the site directly adjacent to Redhouse Run (Annotation G).

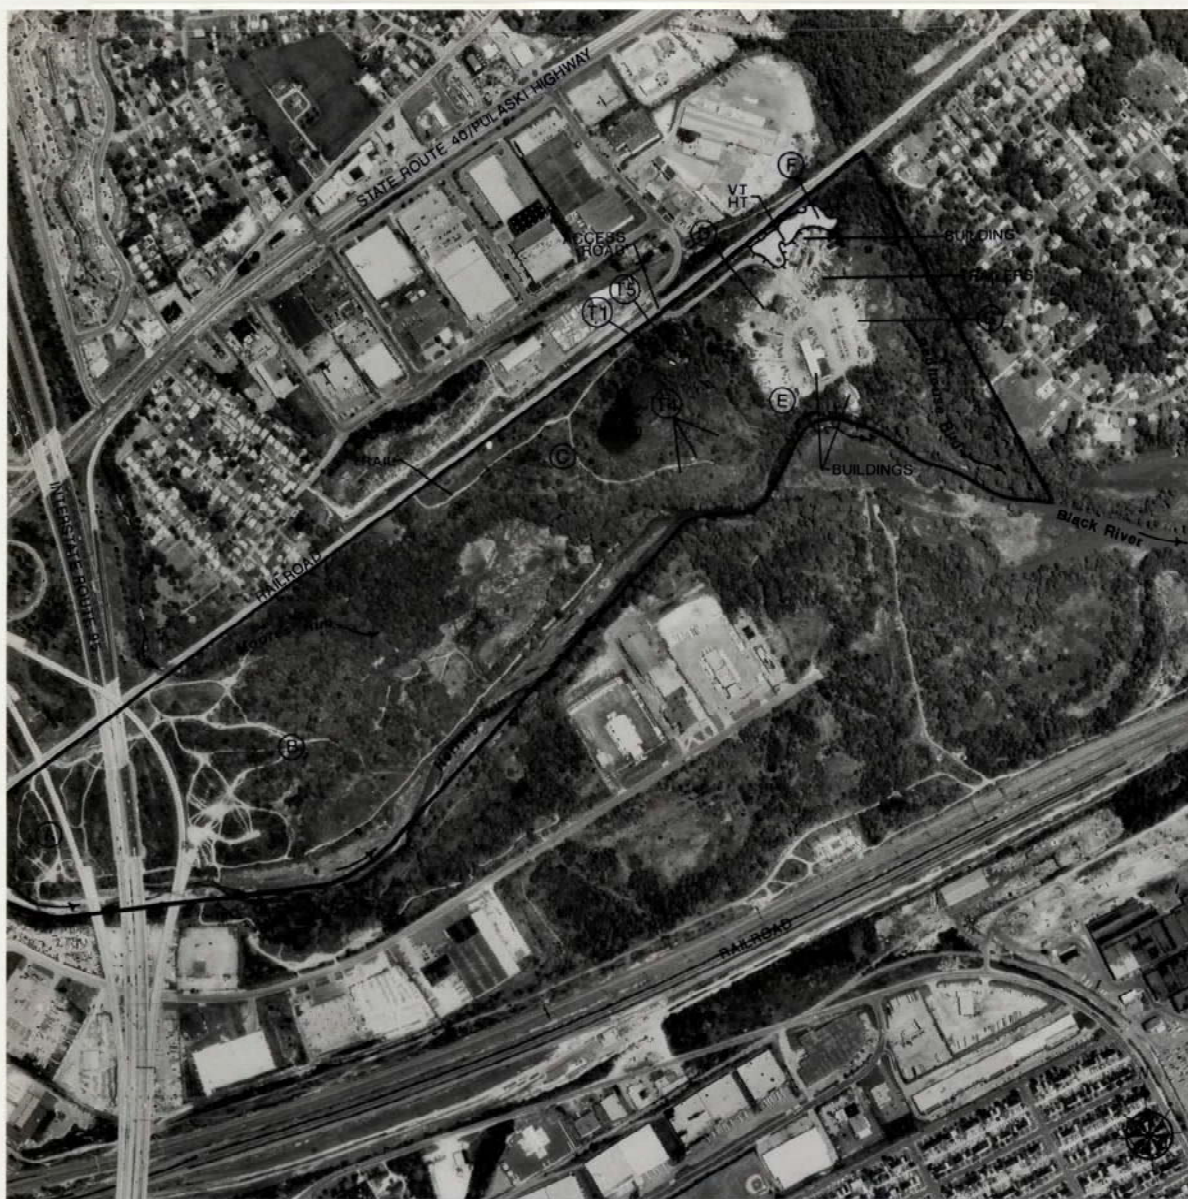
Figure 10. 68th Street Dump, May 1992. Approximate scale 1:8,570.

Since 1984 no significant changes are noted at the west side of the site now occupied by Interstate Route 95 (Annotation A). There are no visible signs of solid waste or debris disposal on the west side of the site. The previously reported trails into the central portion of the site are still visible (Annotation B).

The dish antenna (Annotation T5) reported in 1984 is present but the radio facility appears overgrown by vegetation (Annotation T1). The new antenna towers reported in 1984 are still present (Annotation T4). Vegetation cover continues to extend over former disturbed areas and on the mounds deposited in the central portion of the 68th Street Dump site (Annotation C).

The incinerator has been dismantled and the mound around the former incinerator has been removed (Annotation D). The building south of the former incinerator continues to be surrounded by numerous trailers, trucks, and containers (Annotation E).

Since 1984 additional dumping of light-toned material, possibly fill, has occurred on the north side of the building north of the former incinerator (Annotation F). This mounded material has partially covered a horizontal storage tank reported in 1984. A vertical tank has been constructed in this area. Numerous truck trailers have been parked in an irregular manner in this northeast corner of the site.
